**Eagle Picher
Ohio, Michigan, and Illinois Properties
TDD: S05-0603-003**

Site Inspection Reports

**Subject: Site Inspection Reports
Eagle Picher Ohio/Michigan/Illinois Properties
Technical Direction Document No. S05-0603-003
Tetra Tech Contract No. 68-W-00-129**

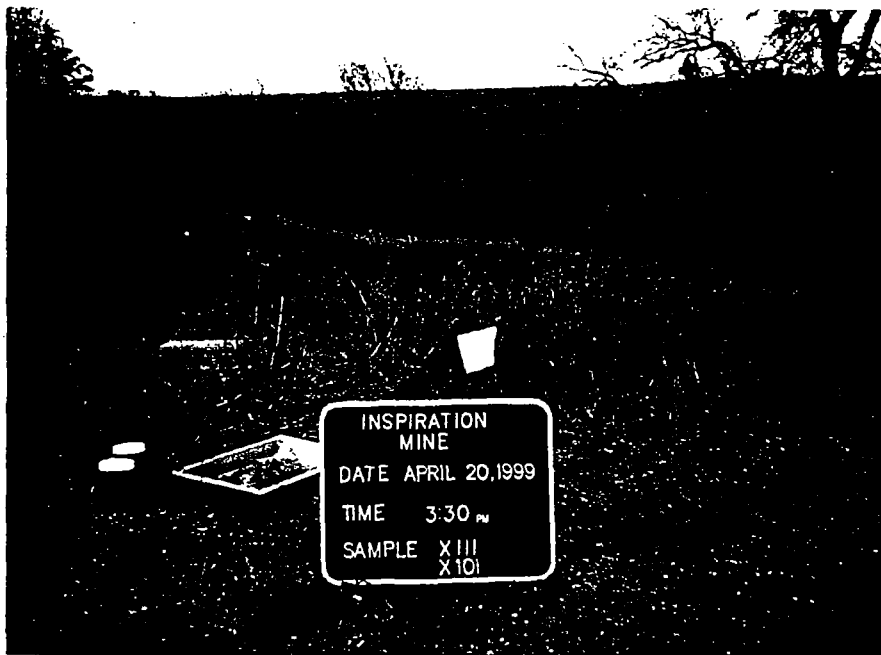
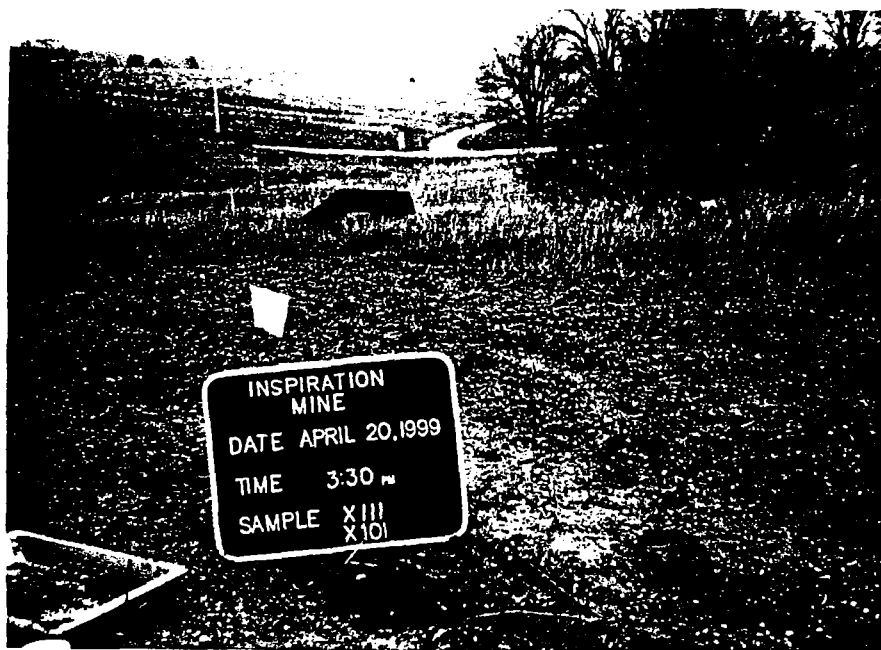
COMMENTS: Photo taken of soil sample collected from former zinc & lead storage pad area.

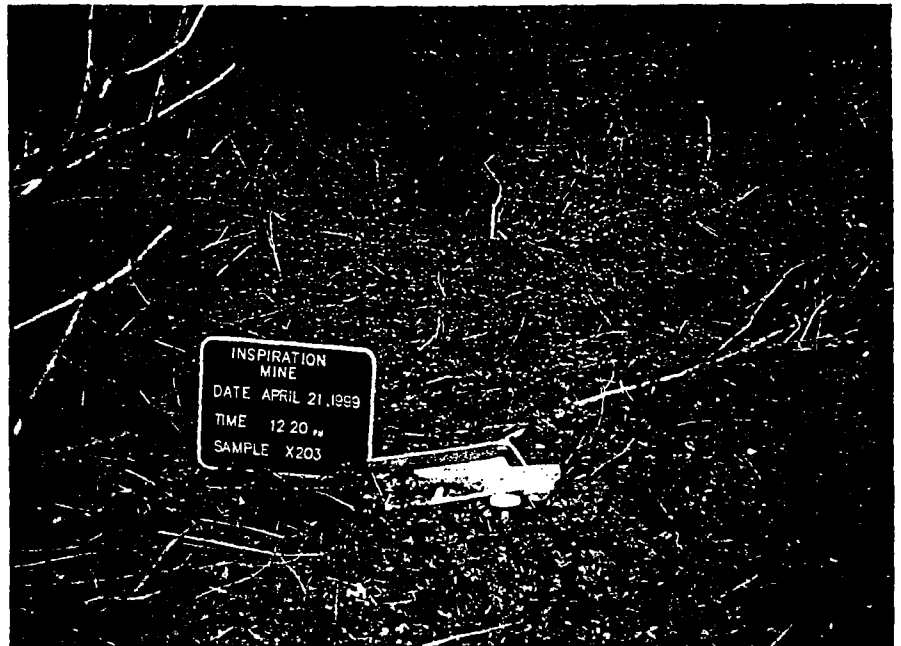
COMMENTS: Photo taken of sediment sample collected in drainage way, south of former pile, leading to Millbrig Hollow.

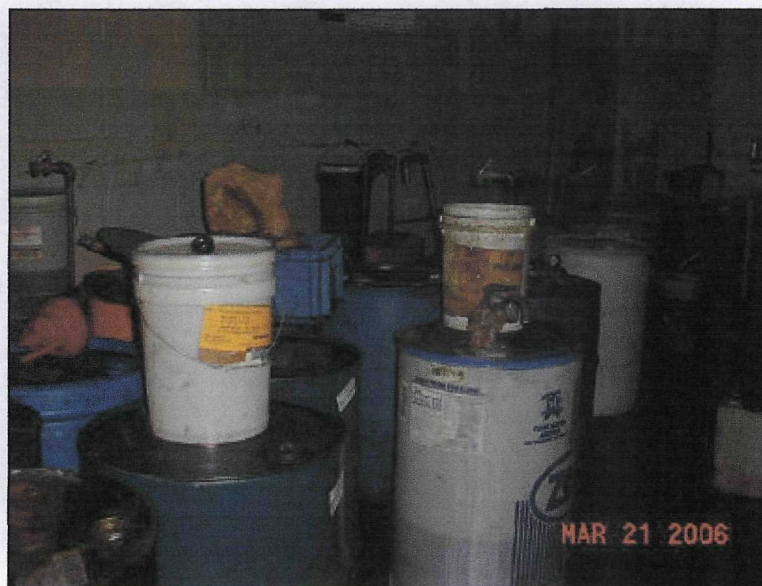
Photograph No. 4 **Date:** March 21, 2006
TDD No.: S05-0603-003 **Orientation:** Inside Building
Location: 135 East South Street, Hillsdale Michigan
Subject: Drums of petroleum product

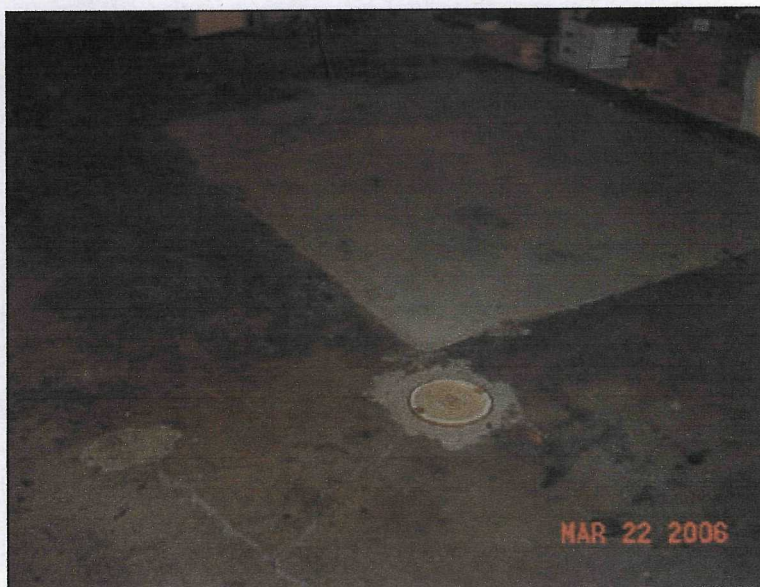
Photograph No. 1 **Date:** March 22, 2006
TDD No.: S05-0603-003 **Orientation:** Inside Building
Location: 2638 Princess and 2424 John Daly, Inkster, Michigan
Subject: Monitoring well. The leaking UST (Toluene) was removed from this area.

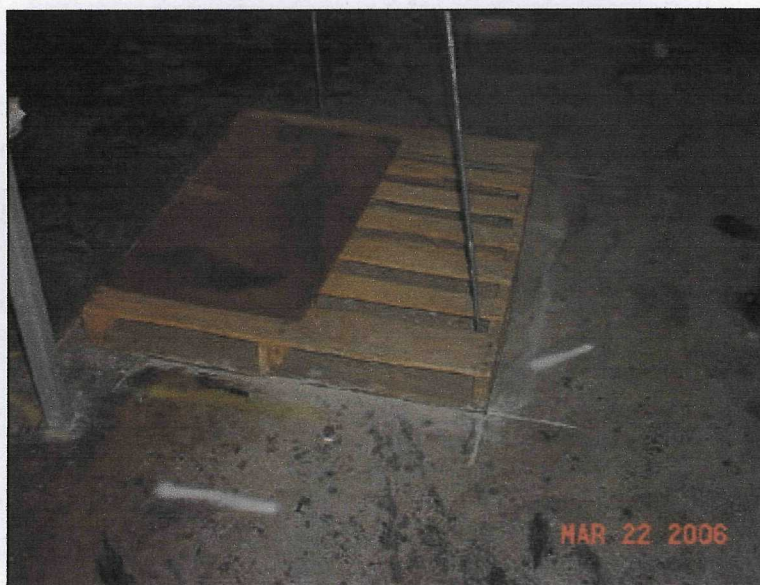
Photograph No. 2 **Date:** March 22, 2006
TDD No.: S05-0603-003 **Orientation:** Inside Building
Location: 2638 Princess and 2424 John Daly, Inkster, Michigan
Subject: Area where an UST for fuel was removed less than 1 year ago.
